FIELD INSPECTION

Project Name: Mountain Valley Pipeline Date: Wednesday, November 6, 2019

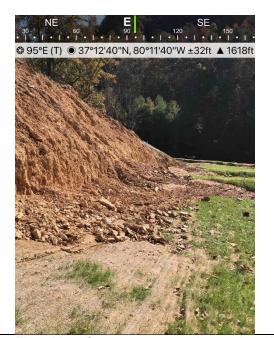
Fig. 1 St12544+00-12540+00 waterbars and stockpiles require maintenance.

Recommend Corrective Action: Maintain and install all controls per the approved plan and specs

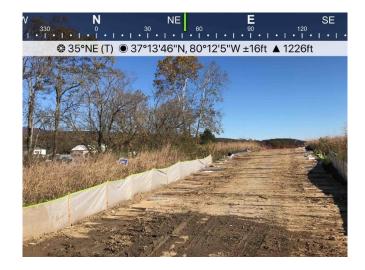
Fig. Near designated stream S-CD12, ECD's are in place and functioning.
